## Bioengineering as a Tool for Restoring Ecological Integrity to the Carson River

**PURPOSE:** This technical note describes a case study involving the following: (a) use of bioengineering (a combination of vegetation and engineered structures and materials) and rock structures to restore an eroded bank of the Carson River, Nevada, and (b) restoration of ecological amenities that existed prior to disturbances by man and a major flood event.

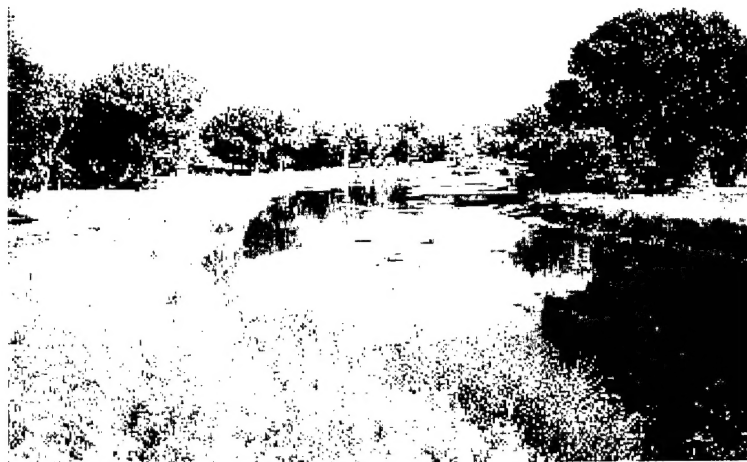
Figure 2. Carson River bendway site in background (left side of photo) prior to any bioengineering treatments

This partnership decided that one damaged bendway with banks that had been cut back 15 or more ft (4.5 m) by the flood would serve as a site to focus a classroom workshop and follow-up demonstration of various erosion control and habitat improvement treatments (Figure 1). The demonstration site was next to residences whose back yards or fields had been eroded along with adjacent riparian vegetation (Figure 2). The flood caused this erosion, but the effects were exacerbated by management activities, such as mowing immediately adjacent to the streambank. The lack of vegetation and storm-caused erosion contributed to a lack of ecological amenities in the riparian zone, e.g., lack of habitat, increased sediment loads, increased water temperatures, and other water quality parameters.

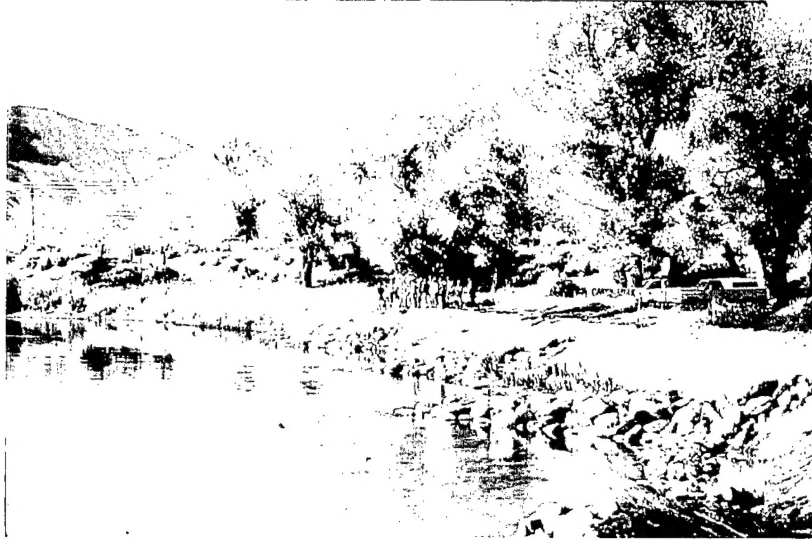
Figure 3. Bioengineering treatments between rock barbs; the barbs are used to deflect currents away from bank (move the thalweg)

The partnership of agencies conducted a workshop and demonstration (hereafter referred to as a workshop) in November 1998 that was attended by both the general public and various personnel within those agencies. The resource professionals and instructors hosting and presenting the workshop conducted a reconnaissance visit prior to the workshop to characterize the site conditions, identify the demonstration reach, and select treatments. It was determined that various hard structures, such as rock barbs (Figure 3) and dikes would be needed along with bioengineering

**DEMONSTRATION TREATMENTS:** Five stream barbs, such as those shown in Figure 3, along with rock refusals (rock trenches buried into the bank), rock toe protection, and a peaked stone (trapezoidal-shaped) dike running parallel to the bank were selected as hard structures to be used in conjunction with the bioengineering treatments. All of these covered a 600-ft (182.88-m) reach of bendway and were used to illustrate to workshop attendees an array of treatments. The treatments selected were adapted from those presented in previously successful bioengineering efforts conducted on other stream systems (Allen and Leech 1997, Bentrup and Hoag 1998).

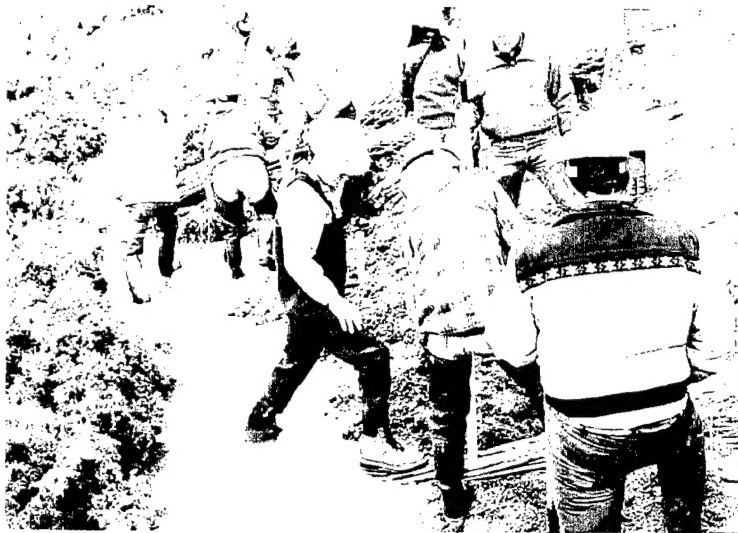
Figure 5. Installation of vertical willow bundles landward of juniper tree revetment; the tree revetment served as toe protection between two barbs and promoted sediment deposition

Five bioengineering treatments were used either between the five barbs or landward of a peaked stone dike (Table 1). Three of these treatments consisted of live, but dormant cuttings of coyote willow (*Salix exigua*) arranged in various configurations, such as vertical bundles (Figure 5) with a juniper tree revetment as toe protection. The other two treatments consisted of brush mattresses, one of which had a rock toe and one that did not. A fourth treatment consisted of live willow clumps of coyote willow with roots attached and buried landward of a juniper tree revetment that served as toe

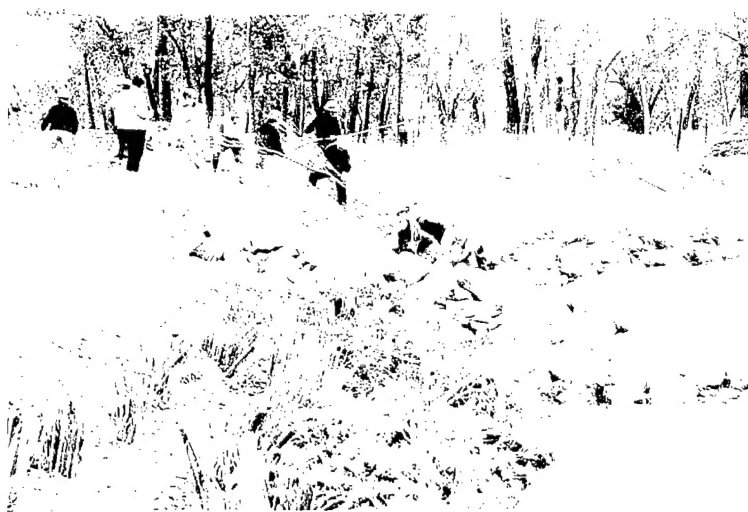
Figure 6. Three bioengineering treatments: (a) live willow clumps with a juniper tree revetment (foreground); (b) workshop attendees installing brush mattress with rock toe protection (middle of photo); (c) brush layering over peaked stone dike (far right of photo). Erosion control fabric with seeded riparian grasses appears on upper bank on left side of photo

protection between two of the barbs (Figure 6). The fifth bioengineering treatment, called brush layering, was installed using dormant cuttings of willow along the inside face of a peaked stone dike (Figure 6). The area was backfilled after installation and provided immediate overhanging shade and cover of the stream to promote aquatic habitat.

Three of the treatment areas were planted with a mix of native riparian grasses and covered with a commercially produced erosion control fabric (ECF) composed of coconut husk fibers (Figure 6).

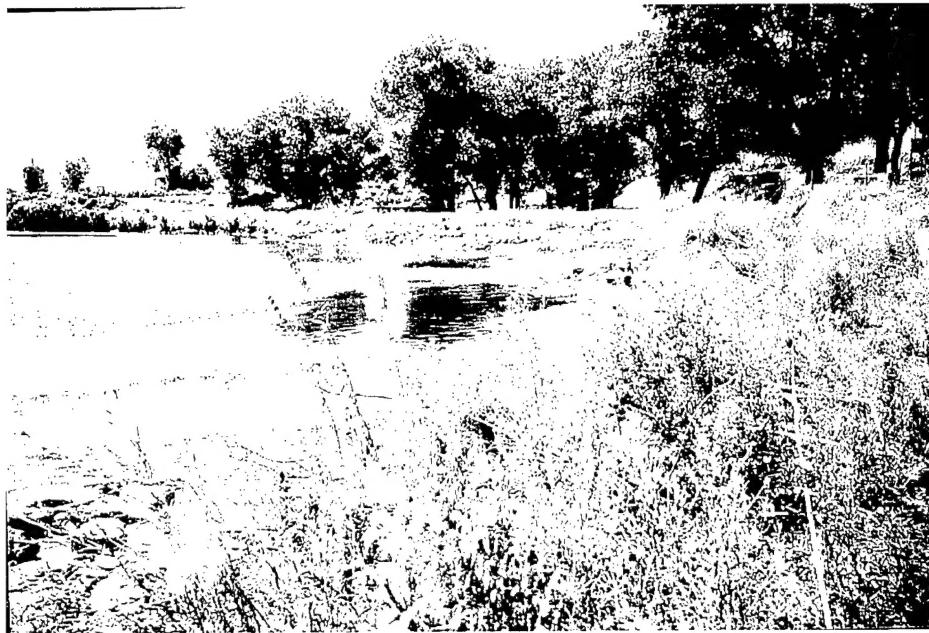
Figure 7. View upriver in August 2000, 21 months after installation of bioengineering treatments; the peaked stone dike with brush layering is shown in foreground
